CRABforOERE

Compendium of CR performance in different climatic zones and critical review of the impact of mixture composition on performance

Deliverable D2

**Cold Recycled Asphalt Bases
for Optimised Energy & Resource Efficient Pavements**

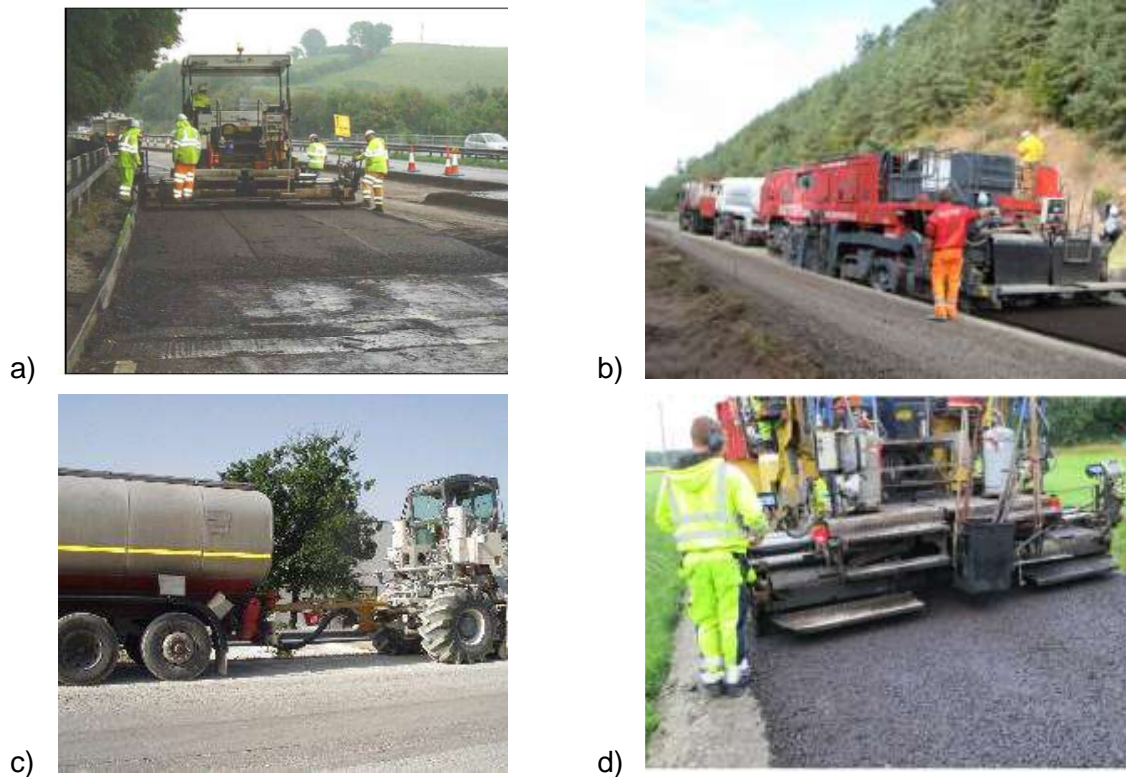
Figure 1. Application of CR techniques: a) CCPR on road A38 in the UK, b) CIR on road B52 in Germany, c) FDR on road SP 18 in Italy and d) CCPR on road Lexby in Sweden.

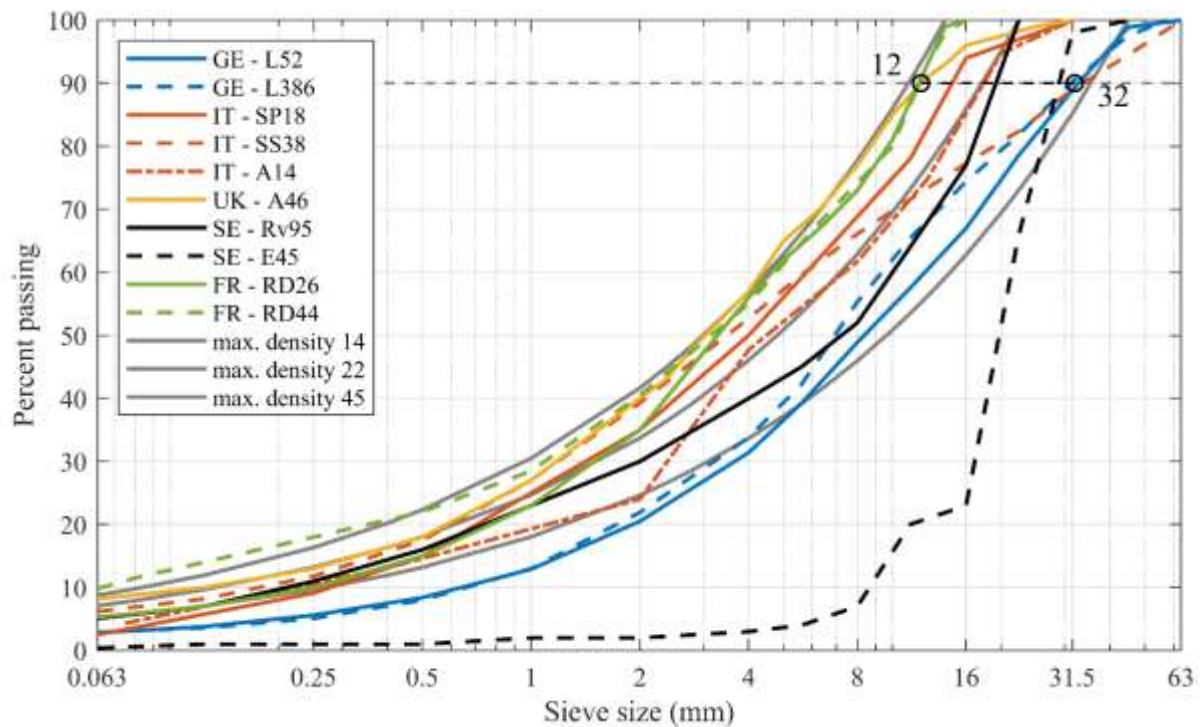
Figure 4. Particle size distribution for all roads where information was available.

In general, it is believed that a high content of fines is beneficial for CRM mixtures because, together with bitumen emulsion or foamed bitumen, and cement (if adopted) it allows the formation of a “binding mortar” phase. However, the characteristic dimension which defines the “binding mortar” is a matter of debate. Here, we compare the passing to the 0.063 mm sieve ($P_{0.063}$) and to the 2.0 mm sieve (P_2).

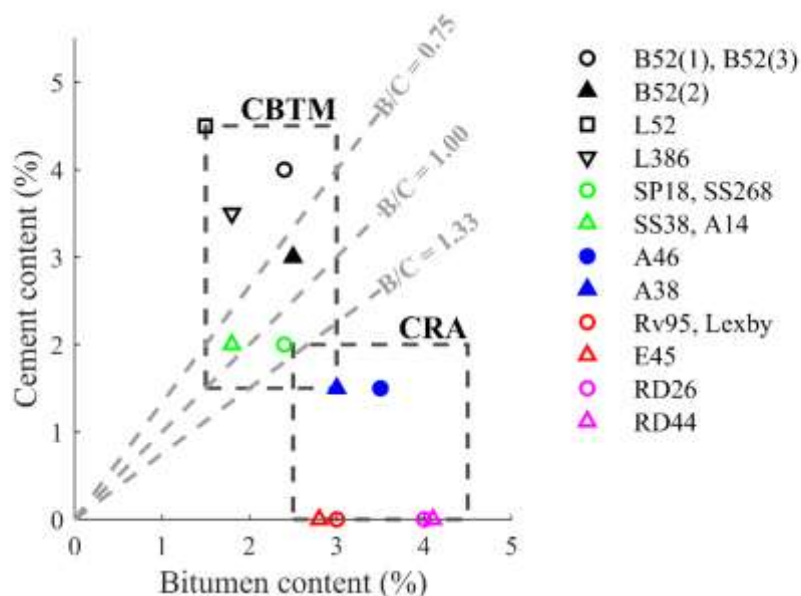
Figure 5. Identification of CRM mixtures families. Filled markers refer to foamed bitumen and empty markers to bitumen emulsion.

The four CRM mixtures from Italy were produced with different techniques but all fall within the CBTM family. They are characterised by similar dosages of bitumen and cement ($0.75 < B/C < 1.33$). The Pavement Catalogue developed by Provincia Autonoma di Bolzano - Alto Adige (Provincia Autonoma di Bolzano, 2016) was calibrated on the results obtained from SS38. The pavements included in the catalogue were calculated considering fatigue but not permanent deformation. Indeed, with those compositions, the CRM mixture is not considered prone to permanent deformation failure. In order to avoid a fragile behaviour due to an excess of cement, an upper limit is imposed on the CRM mixture stiffness.

The four CRM mixtures from Germany were produced with the CIR technique and fall within the CBTM family. The CRM mixture produced with foamed bitumen (B52(2)) has a $B/C = 0.8$, close to the values of the Italian mixtures. The CRM mixtures produced with bitumen emulsion are characterised by a higher dosage of cement ($B/C < 0.6$). Due to this high cement content they may be prone to shrinkage cracking, especially in their early life.

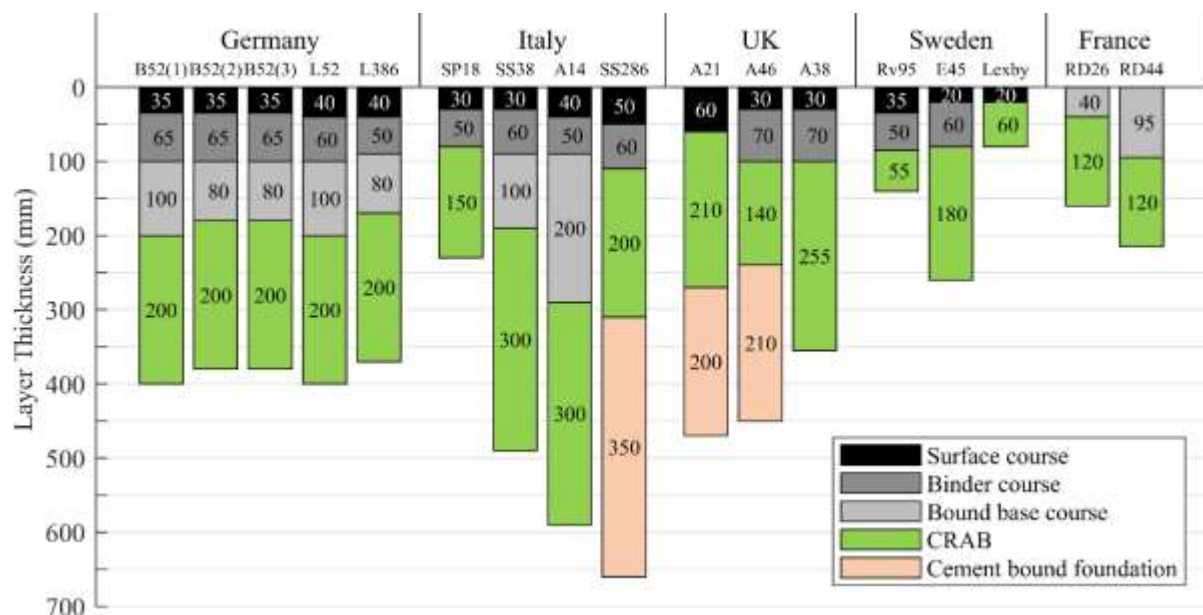
Figure 6. Layer thicknesses for the 17 studied road sections illustrated from the surface down to the deepest bound layer.

Structural designs for the road sections included in this project are presented from the surface layer down to the deepest bitumen/cement bound layer. This is the CMA layer for all road sections except for two of the UK sections and one Italian section where the CRAB layers rest on cement bound foundations. All these layer thicknesses are presented in Table 4 and graphically in Figure 6. Layer thicknesses evaluated from extracted core specimens are presented in Chapter 6. The last column in Table 4 indicate what is believed to lie beneath the bottom bound layer. Information on these underlying was not always available, and the right column can thus be seen as an engineering judgement.

Regarding the sections from Germany, the thickness of the bound layers doesn't show an influence of the actual traffic loading. A reason for this can be, that the cold recycling procedure in Germany is applied only for recycling of tar-contaminated pavements in new road structures. Here, sometimes the aim is to recycle a high amount of reclaimed road materials even if this is not necessarily required according to the loading conditions. The pavement structure of road B52 which shows the highest traffic loading fits well to the "common" regression.

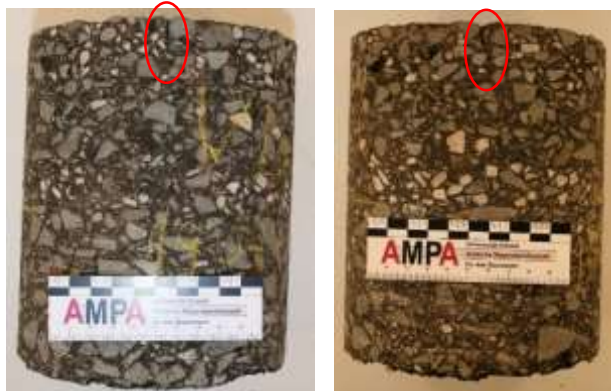
Cracks on the surface course were visible on these cores, named L386_6 and L386_7, which are displayed in Figure 9. These cracks are only visible withing the surface course. The CRM layer (bottom) is not deteriorated.

Figure 9. L386 cores extracted from cracked zones.

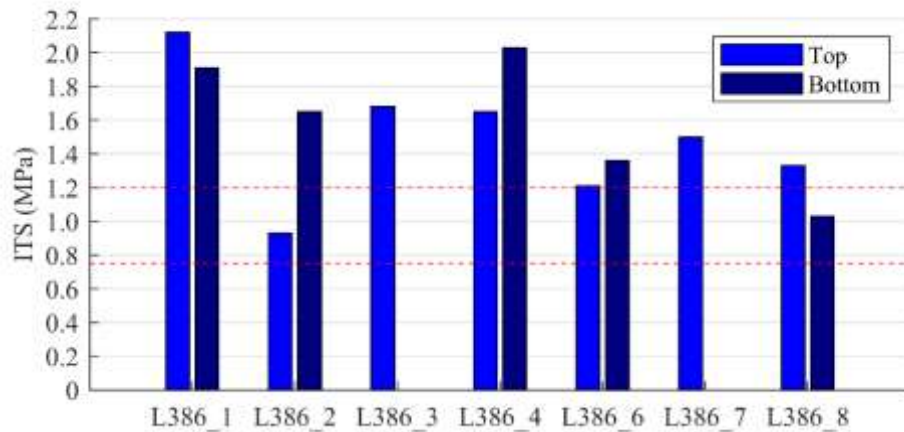
Minimum and maximum strength limits for specimens 28 days after compaction according to German mix design specifications (FGSV, 2005) are identified with red dotted lines.

Figure 11. Indirect tensile strength values of top and bottom specimens prepared from each core. Red lines mark limit values according to German specifications.

Firstly, the measured strength values vary between 1,18 and 2,02 MPa and therefore show a high range of strength values. There is no obvious difference between the strength measured at the top specimens to the bottom specimens from the cores. This indicates, there is no systematic difference during the height of the layer due to compaction or other effects.

The ITS obtained for the specimens from cores L386_6 and L386_7, which were taken from cracked zones of the pavement, doesn't differ from the general strength range measured.

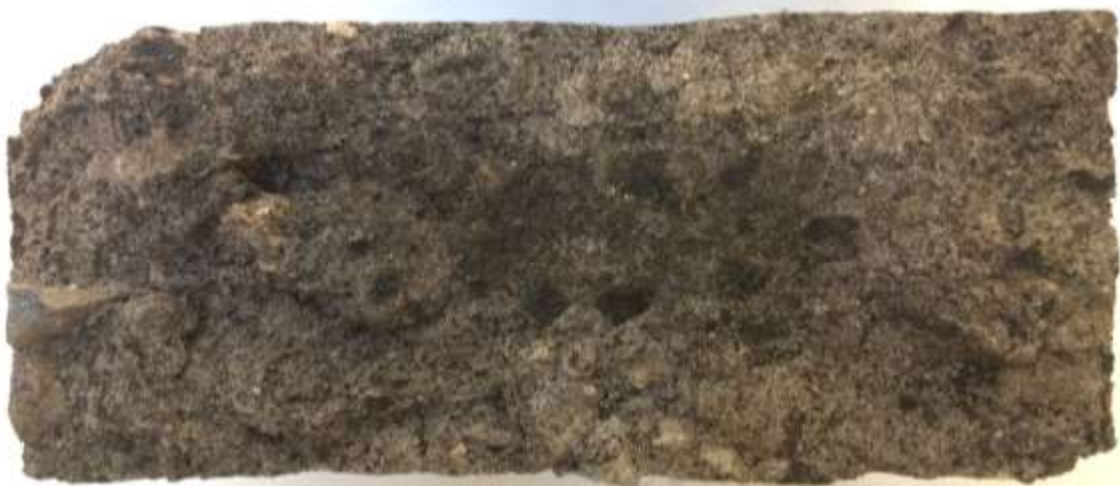
After testing the cores, the fresh surface, displayed in Figure 12, shows more white/grey zones than black zones, indicating more cement bonds compared to bitumen bonds. This is an effect of the high cement content applied in the L386 pavement. This also refers to the comparatively high indirect tensile strength values. In nine of the twelve test results, the measured strength exceeds the maximum limit of ITS allowed during mix design. From the construction data, after 28 days originally an ITS of 1,13 MPa was obtained. This shows that the long-term strength is considerably higher than the mix design specifications limit obtained after 28 days of curing.

Figure 12. Cracked surface after ITS test on specimen obtained from L386

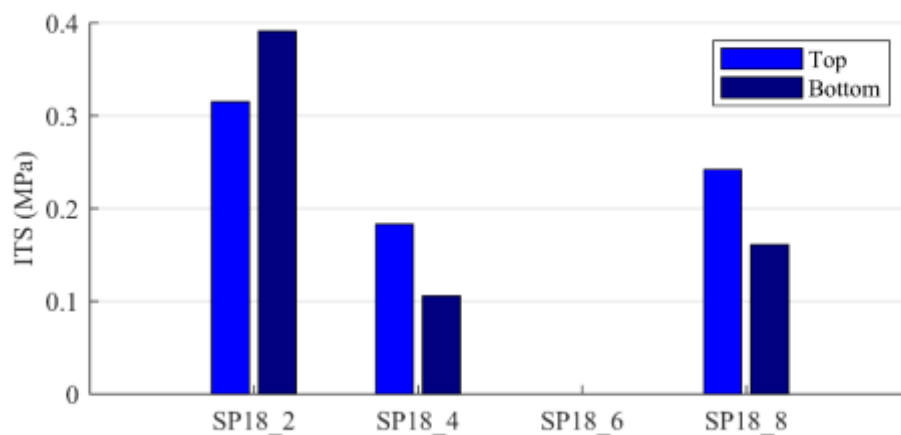
After the ITSM test, the same specimens were tested again to obtain the ITS. The test was performed at a temperature of 20°C and had a constant deformation rate of 50±2 mm/min. Since the specimens from core SP18_6 broke during the ITSM, ITS could neither be tested on these specimens. Evaluated ITS test results are presented in Figure 16 and display a large spread between highs and lows, ranging from 0.106 MPa to 0.391 MPa.

Figure 16. Evaluated ITS results for the SP18 road section.

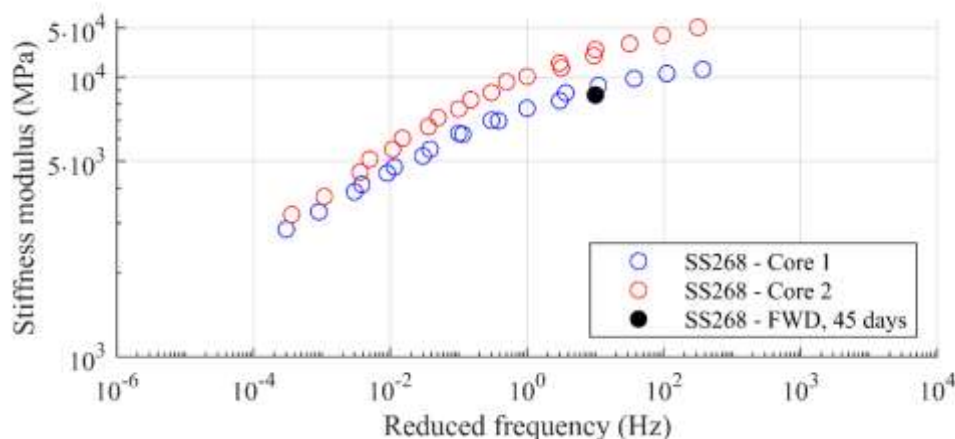
Master curves assembled from two cores specimens obtained from SS268 are presented in Figure 19 together with the falling weight deflectometer (FWD) test results 45 days after construction. The actual FWD result which is an average value from multiple drops is transformed to represent the CRM mixture stiffness at the reference temperature of 20°C with the testing frequency of 10 Hz. The FWD stiffness at these conditions gave a stiffness of 8641 MPa which is corresponding very well with the master curve data.

Figure 19. Master curves assembled for two cores obtained from SS268 at the reference temperature of 20°C together with a corresponding FWD measurement for the CRM mixture.

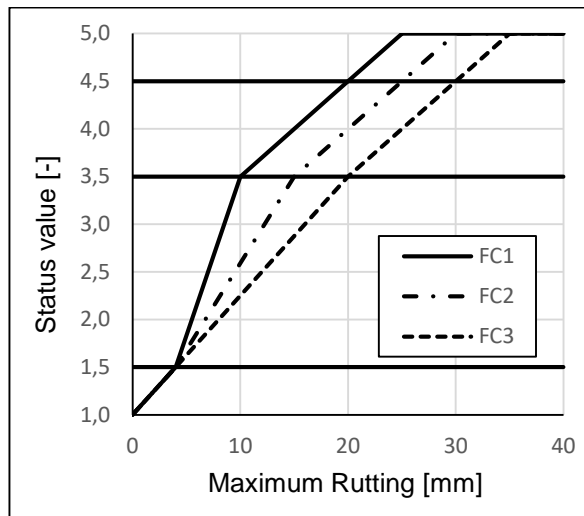
Figure 31. Nomogram for evaluate rutting

documentations of the sections either by photos taken during visual inspection or Google Street View pictures. Rutting data was also collected along some test sections. For the available data, different types of nomograms were given (see Figure 31 and Figure 32). Within the rutting-nomogram, different function classes are available depending on the distribution of traffic.

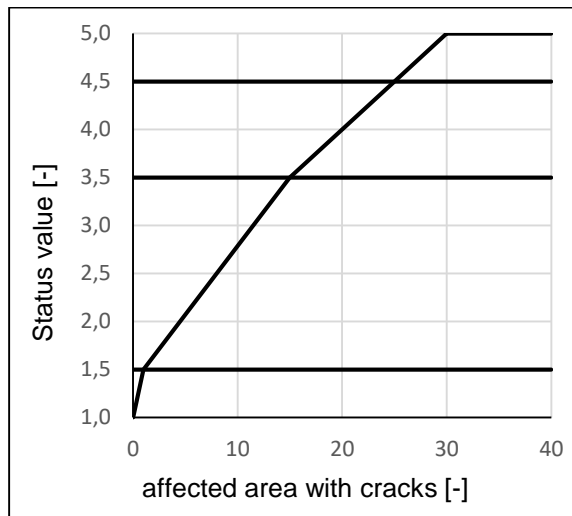
Figure 32. Nomogram for evaluate cracking

To assess the performance of each section's structure, measurement data as well as visual assessment were used. According to the German standard for condition monitoring (FGSV, 2006), each assessed road structure was split into 10- or 100-meter sections depending on the individual total length. The proportion of cracked surface was observed by using photo

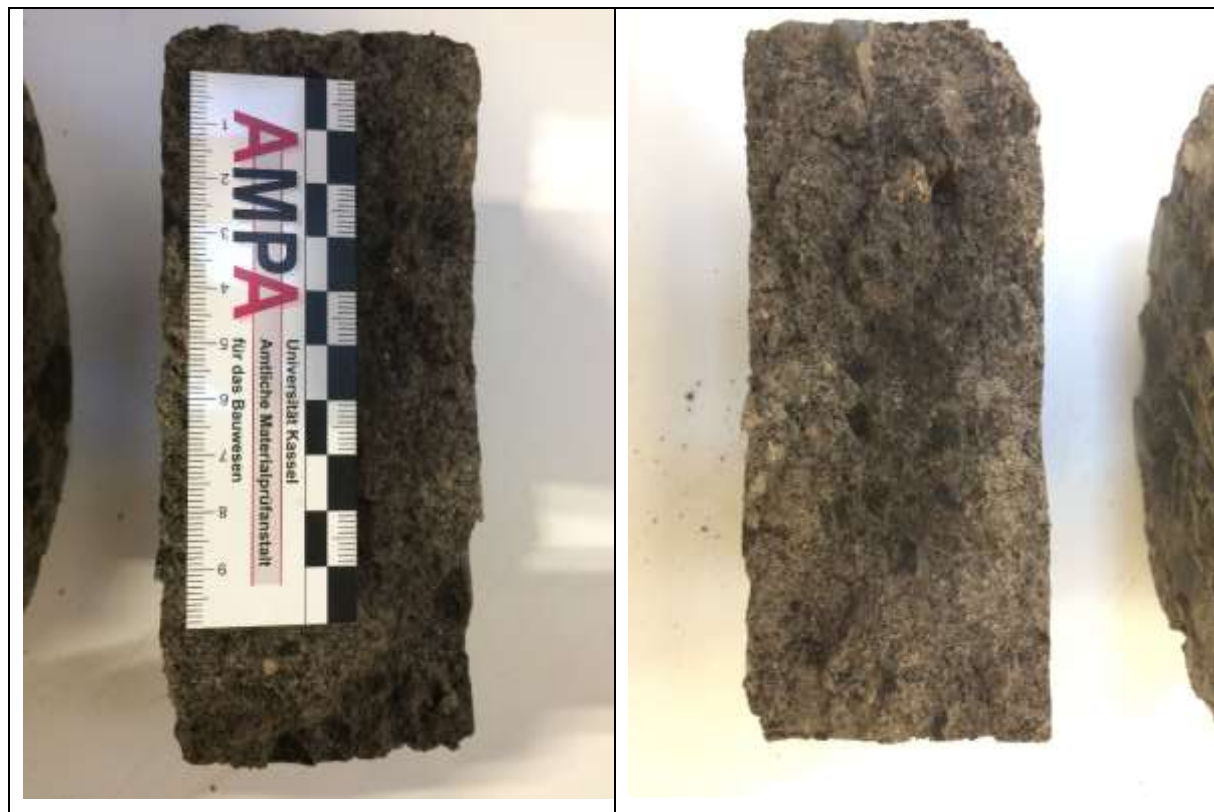
Figure 38: CRM of BK6 after testing on ITS.

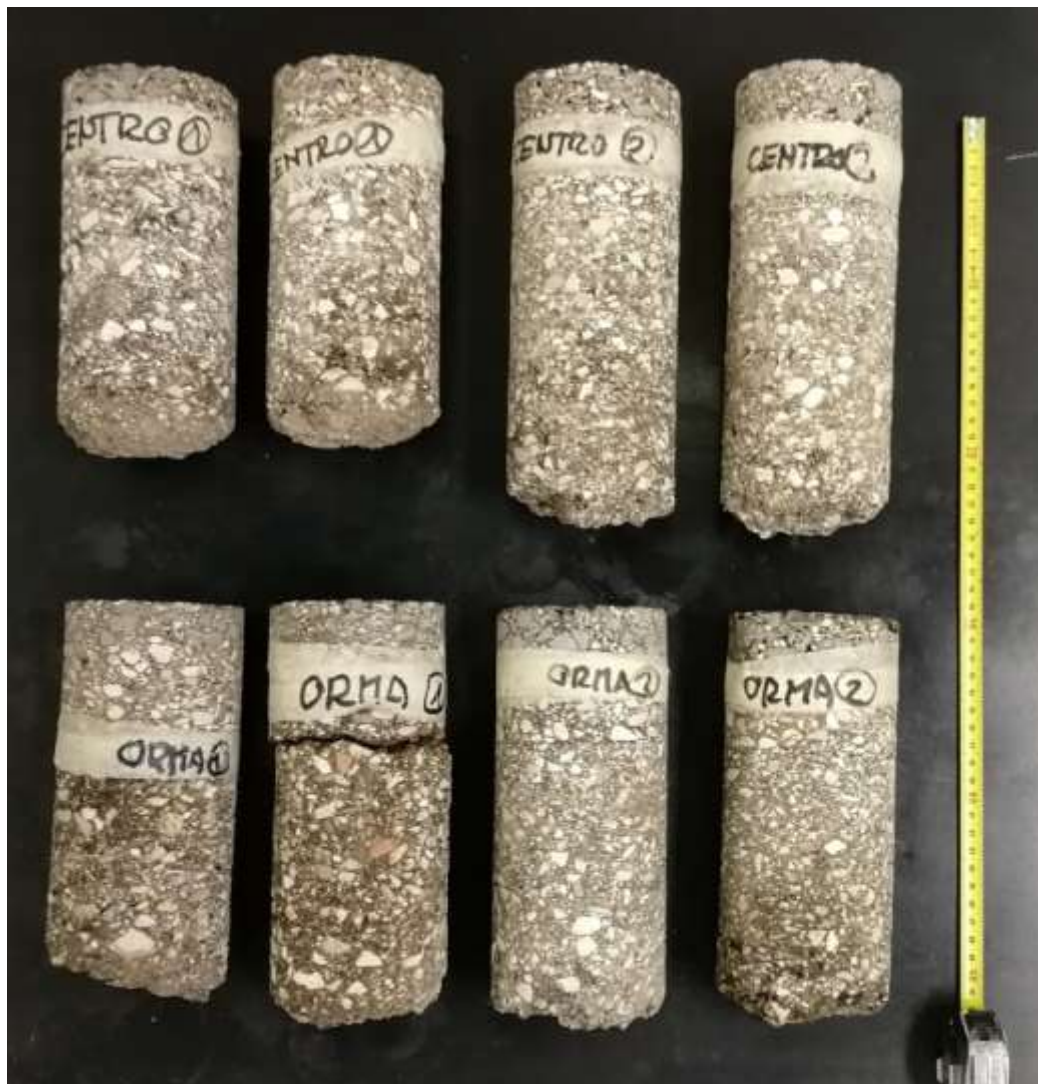
Figure 40: SP18 cores taken in October 2019. From the top-left, first row: C1.1, C1.2, C2.1, C2.2; second row: W1.1, W1.2, W2.1, W2.2

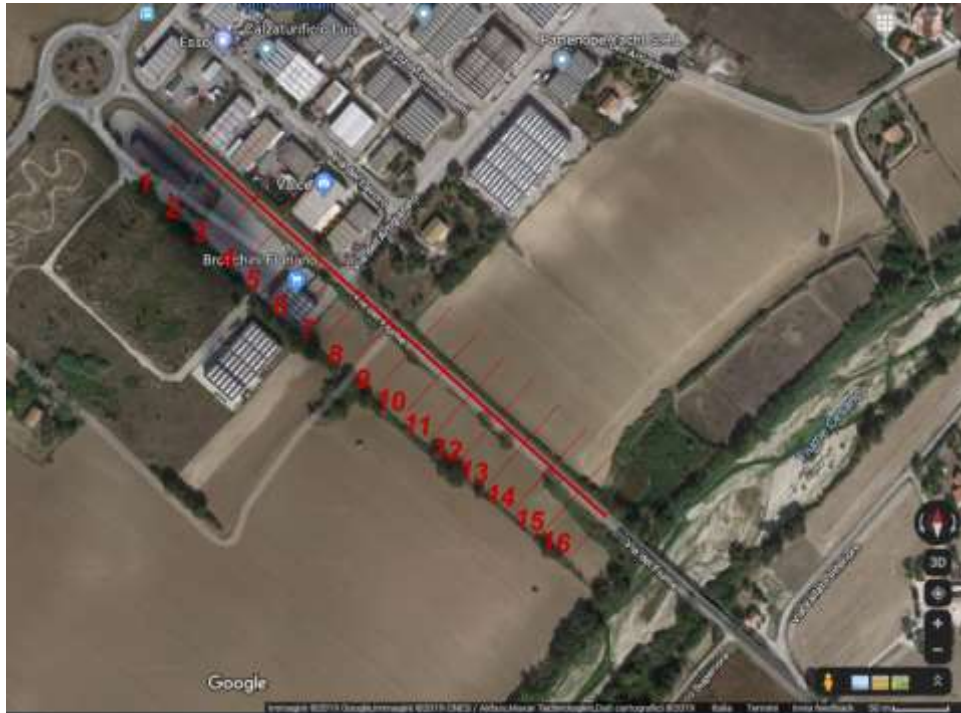
Figure 42. Sample units for the pavement condition survey

The PCI obtained for the pavement section is 68, representative of fair conditions. The assessment of the causes of the distresses revealed that 64% of distresses are due to traffic load, and 36% to climate.

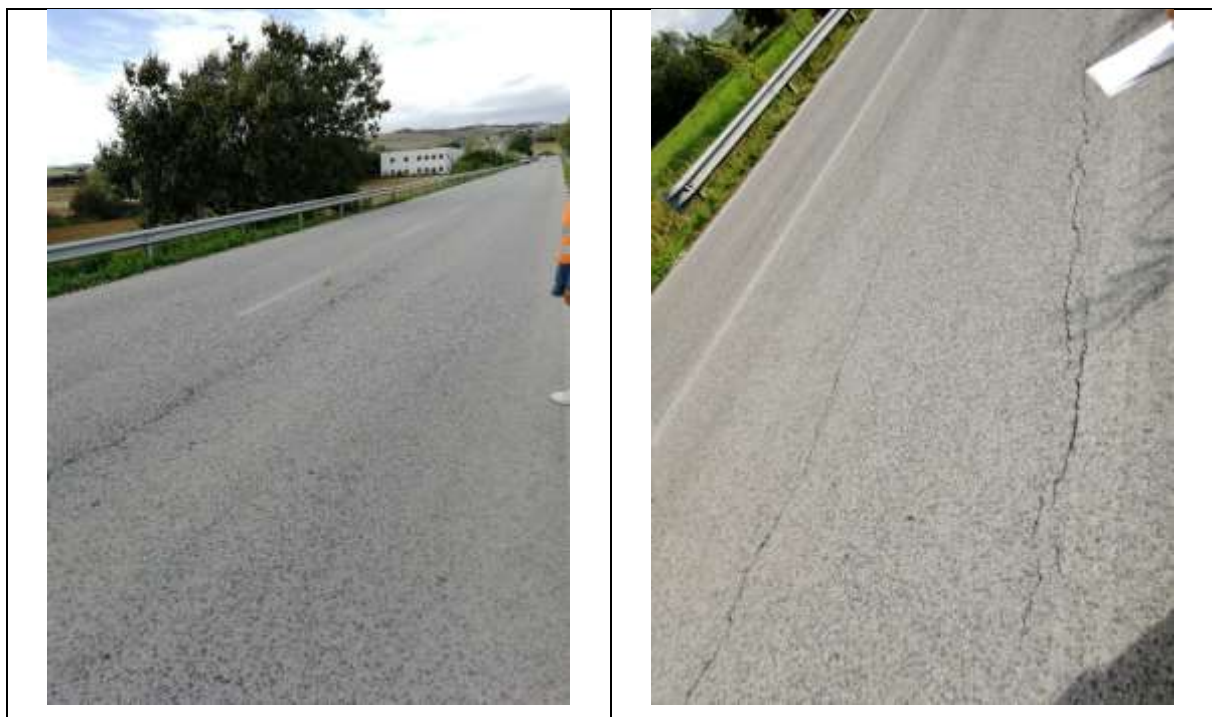
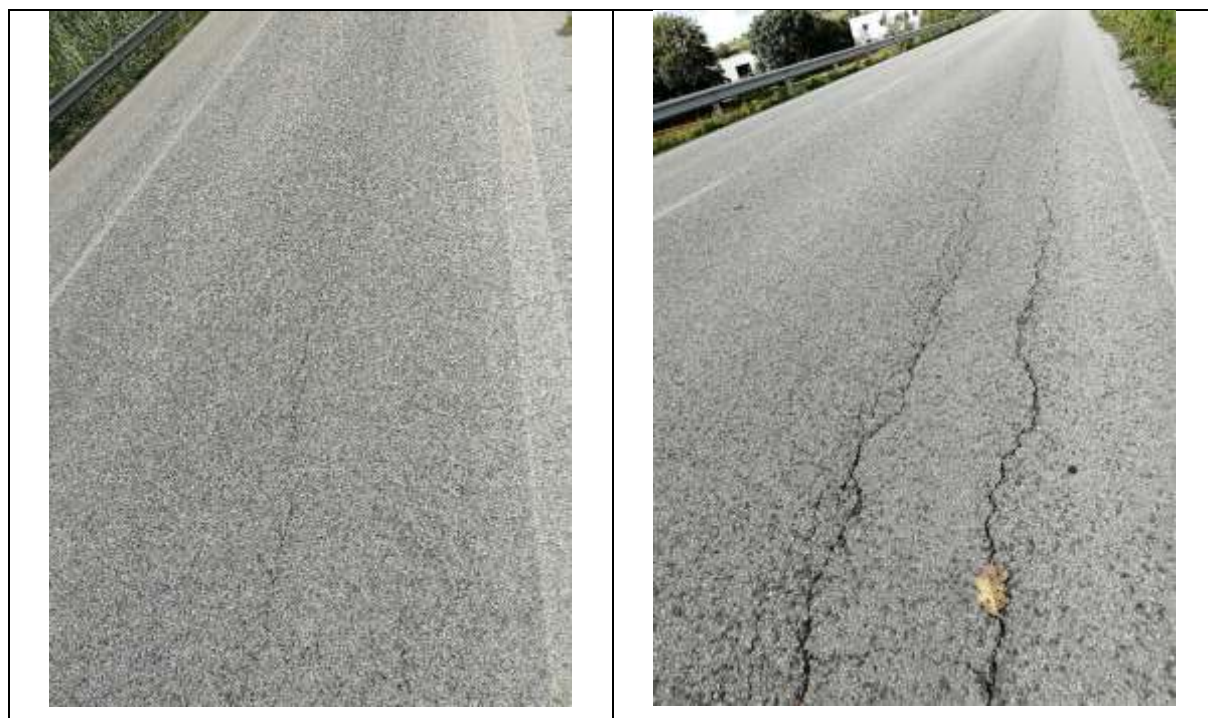
Figure 43: SP19 general pavement conditions
